ABRASION PROTECTION OF LINATEX TOWER

Quarry, Scotland UK

2019

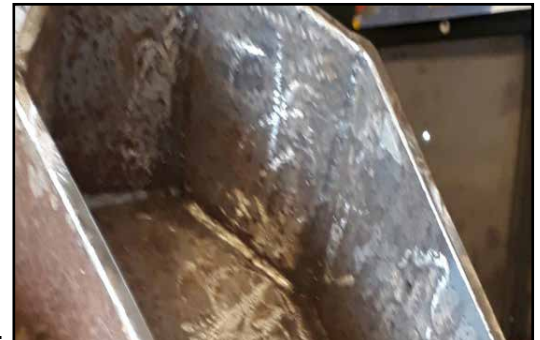
The abrasive qualities of sand had resulted in wear and holes on the steel chute. The equipment only lasted six months before wearing out, so a more permanent solution was required by the client.

1. Equipment prior to coating
2. Application of Belzona 1321
3. Tiles grouted in-place
4. Completed application after six months in service

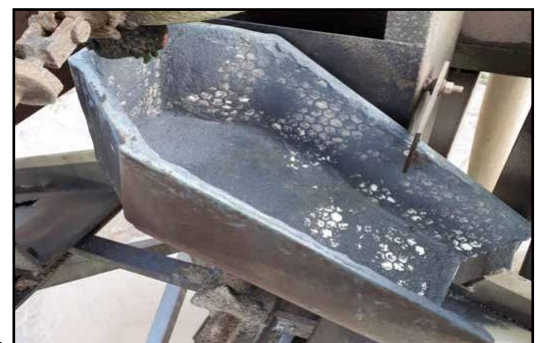
4.

The service life of this part is normally six months. Fabrication of a new chute cost around £500, plus a day lost for production every 6 months. The cost of the Belzona repair was 25% less and is still showing no signs of deterioration.
