STRUCTURAL REINFORCEMENT OF NOZZLE WITH BELZONA SW II

Nozzle of process vessel suffering from internal corrosion and significant thickness loss. A carbon fiber polymeric compliant repair was needed, to comply with the structural reinforcement design of the equipment, and allowing for its operational continuity and reliability.

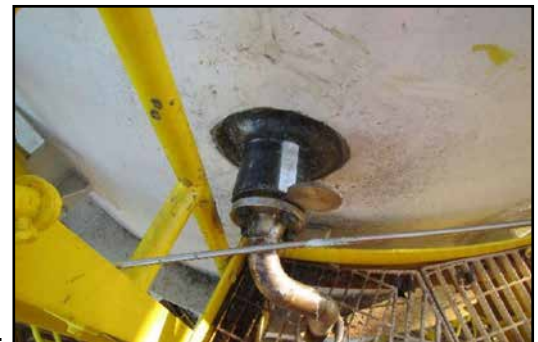
1. Overall view of finished repair
2. Overall view of finished repair
3. Overall view of finished repair
4. Close-up view with metallic id tag

Surface preparation was performed in accordance with SSPC SP11 with a MBX, achieving the required surface roughness for the application. After surface cleaning to get rid of oil and contamination, Belzona 1311 was used to bond a metallic coupler. The Belzona Superwrap II system was then applied around the nozzle and in part of the tank wall, with a final thickness of 6mm.
