## BELZONA PROTECTS SHIP SCRUBBER SYSTEM DISCHARGES

SHIPYARD, TURKEY

Scrubber Overboard Discharge area of RO-RO ship

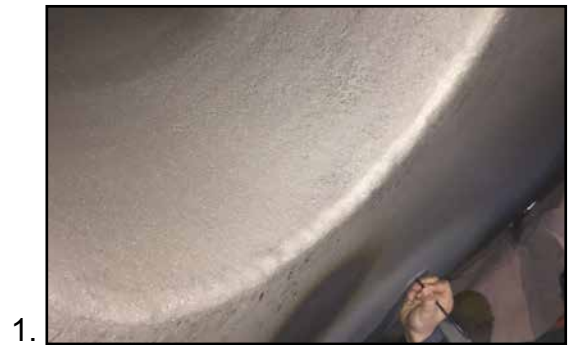
1. Surface has been prepared and cleaned
2. Scrubber Discharge pipe Coated
3. Applying first coat of Belzona 1391T
4. Applying final coat of Belzona 1391T

The application was carried out in accordance with Belzona Know-How System Leaflets SOS-02. Surface was grit blasted to achieve SA2,5 standard. Surfaces salt containment measured and surface has cleaned with Belzona 9111 Cleaner&Degreaser. Specified Surface area is coated with 2 layers with Belzona 1391T. After the application, coating allowed to cure and post cured respectively.
