BELZONA SOLVES TANK BASE SEALING PROBLEMS

Oil Terminal, Scotland

October 2020

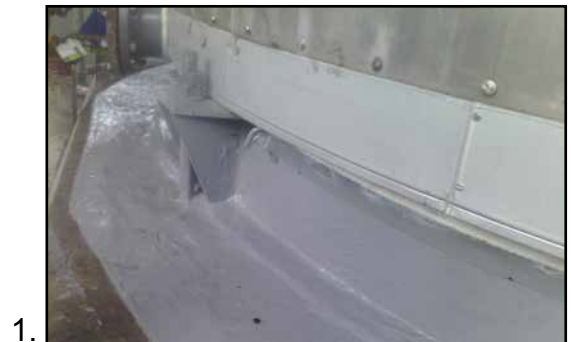
1. 2,3,4 - finished image of Belzona system around annular rim

The application was carried out in accordance with Belzona System Leaflet GSS-03. The base of the tank was grit blasted, Belzona 6111 was then applied to provide corrosion protection. Bridging tape & Belzona 3921 were applied & then Belzona 3111 as a two coat system.

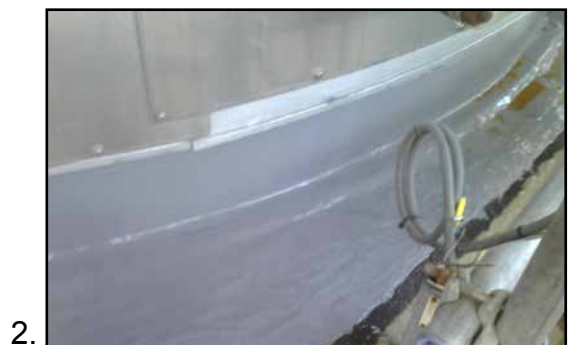
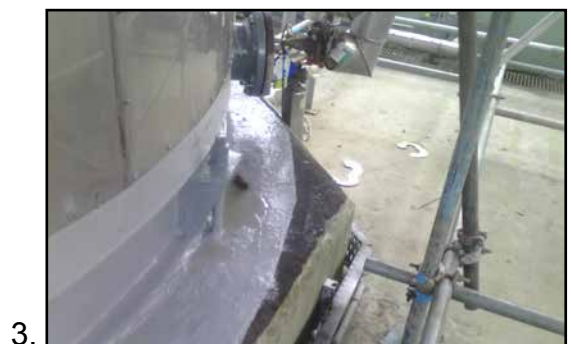
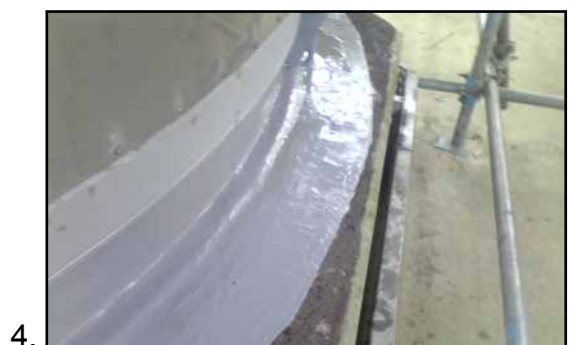
The flexible micro-porous system effectively sealed the tank annular rim from any external water penetration.
