BELZONA TAKES THE HEAT OFF

Huelva, Spain

Hot pipeline operating in a heavily contaminated and dirty environment, in a copper production plant.

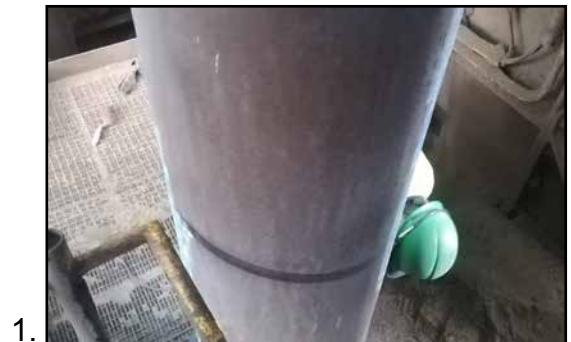
Due to the contamination and dirt found in the environment close to the pipeline, the insulation material had degraded and was no longer fit for purpose. Unfortunately, this left the hot surface of the pipeline exposed, causing a hazard to personnel working in the area. The pipeline operated at between 80°C and 100°C. The surface must be below 60C to be considered safe.

1. Pipe prior to application
2. Surface preparation completed
3. Application completed
4. Surface temperature after curing
