BELZONA 4131 WASH ROOM FLOOR THIRTEEN YEARS LATER

Young offenders Secure Unit

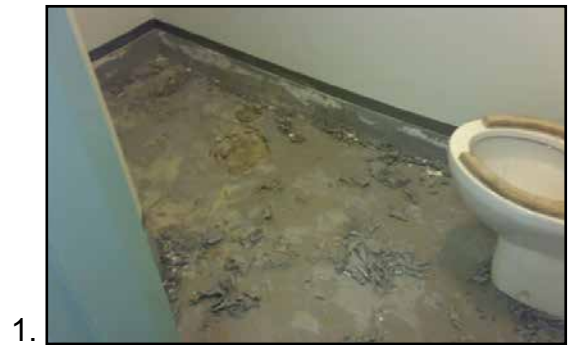
The wash room coating and substrate beneath had collapsed causing health and safety issue for the inmates of this secure unit.

1. Original unrepaired condition
2. Belzona 4131 build in sections
3. Completed Application 2007
4. Condition Assessed 2020

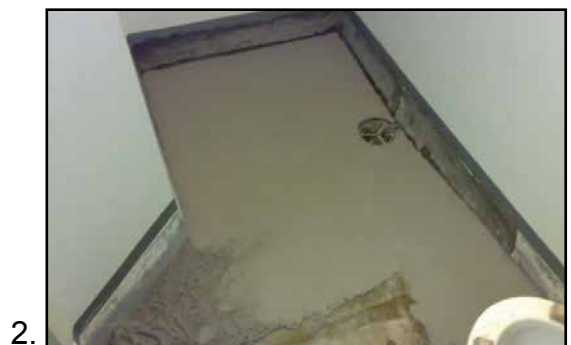
The application was carried out in accordance with Belzona System Leaflet FPA-01. All debris removed and substrate suitably abraded leaving a dust free and clean area to apply Belzona Conditioner. Belzona 4131 Magma Screed was applied in four differing sections ensuring the 'fall' was correct and leaving a safe, underfoot grip system.

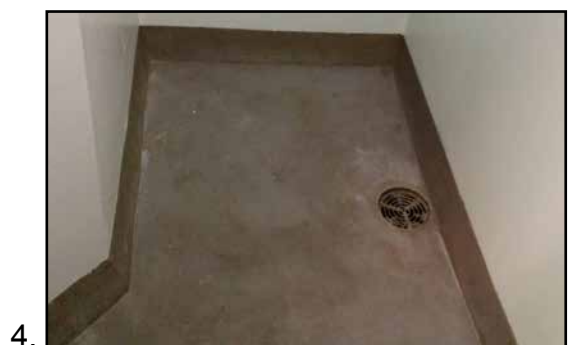
The Client required a seamless floor finish and very safe system which would not degrade. Following this and inspection during 2020, the wash room floor surface was in excellent condition with very little wear. However, other floors had been repaired with cheaper alternative products have now failed and Belzona invited to install some sixteen floors using the Belzona 4131 system
