BELZONA PUMP REPAIR IN A SUGAR FACTORY

Repair and coat a Nash vacuum pump in the Sugar Industry.

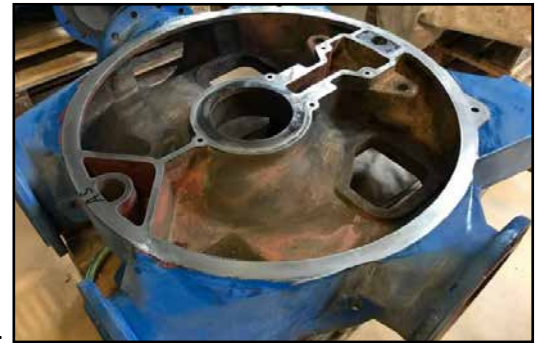
The long running time and high loads resulted in wear damage and corrosion on the housing. The flanges on the housing were washed out by installing the wrong seals.

1. Damaged Pump
2. Coating Internals of the pump.
3. Completed Internals of pump.
4. Completed Pump
