BELZONA LAYS NEW CHEMICAL FOUNDATION IN FOOD SECTOR

Finland

August 2020

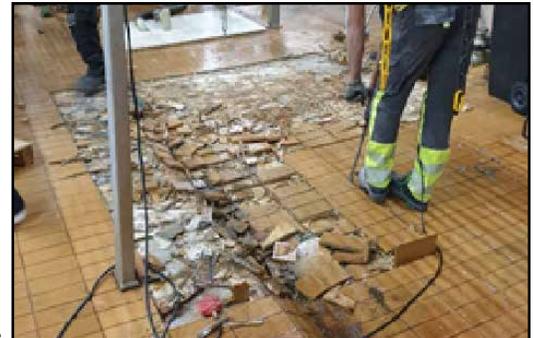
1. Old floor de-assembly
2. Deeper areas (2-30cm) filled with Belzona 4154
3. Belzona 4111 used to reach the final level
4. Belzona 4311 used as a top-coat, a final chemical resistant and safe floor-surface is achieved.
