BELZONA REPAIRS AND PROTECTS AN LEV UNIT

Harrogate, UK

6/08/2020

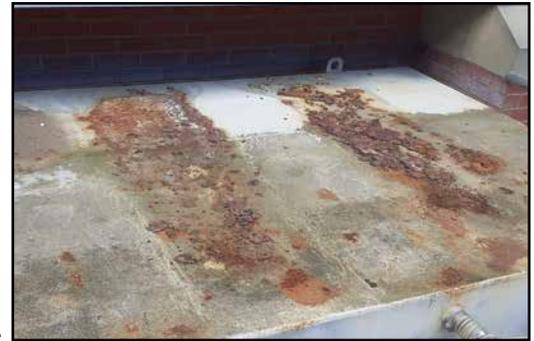
The top of the asset had been left exposed and without sufficient protection for a number of years. This had resulted in extreme corrosion in areas leading to a number of through wall areas and severe pitting. Which over time has resulted in large amounts of water being trapped within the unit - soaking the filters housed within.

1. Picture of the surface prior works
2. Image of the partly prepared surface
3. First coat of Belzona 5831(ST-Barrier)
4. The finished application
