LEAKING PARAPETS ON GRADE 1 LISTED CHURCH COATED WITH BELZONA 3131

Birmingham, UK

3rd August 2020

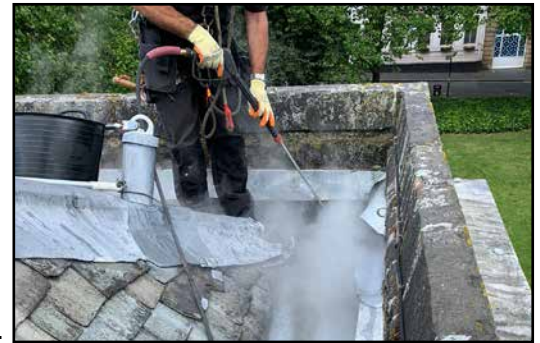
1. Cleaning the substrate with Doff Cleaning machine.
2. Lead parapet prior to application
3. Completed Application

The parapet of the roof was cleaned using a Doff machine at 160 degrees. Belzona 3921 conditioner was applied to the substrate and left over night. A first coat of Belzona 3131 was applied whilst laying Belzona 9361 reinforcing sheet over the top. A second coat of Belzona 3131 applied over the top to complete the application. This was completed in accordance with Belzona System Leaflet RPA-06.

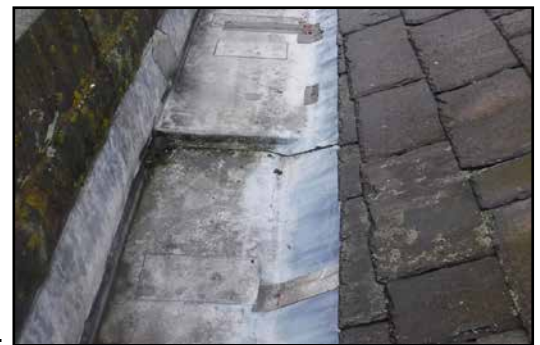
2.

Water was leaking through the damaged/cracked parts of the lead parapet.
