## BELZONA CONTROLS SEVERE ABRASION IN A CONE CRUSHER

Quarry in Croatia

August 2020

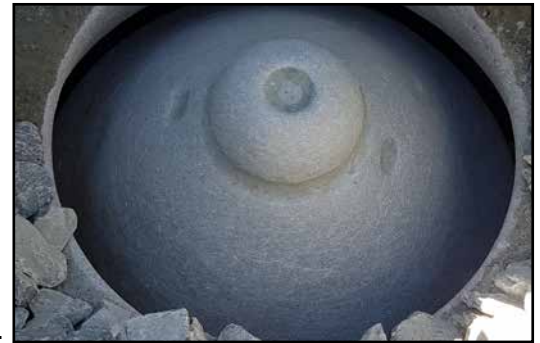
1. Cone crusher - view from above
2. Cone crusher - view from the inside, situation after 11 months of operation
3. Belzona 9811 bonded with Belzona 1121
4. Application finished after grouting with Belzona 1812

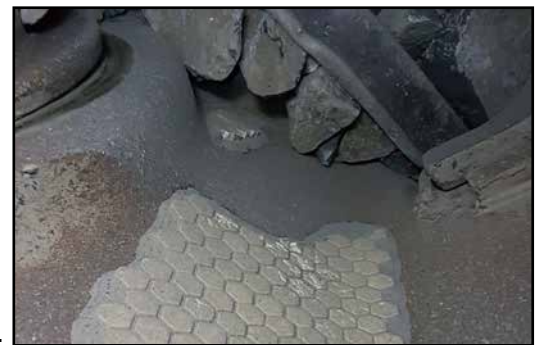
2.

Abrasion is most severe on two positions inside the crusher housing - each size of 20x40 cm. In September 2019, we applied two mashes of Belzona 9811 alumina tiles, bonded with Belzona 1121 and grouted with Belzona 1812. After 11 months, approximately half of the surface was still OK, and the other half (more exposed), needed upgrade.
