BELZONA REPAIRS VALLEY GUTTERS

Huthwaite, UK

A total of 8 valley gutters were in need of repair at a large plastic extrusion company.

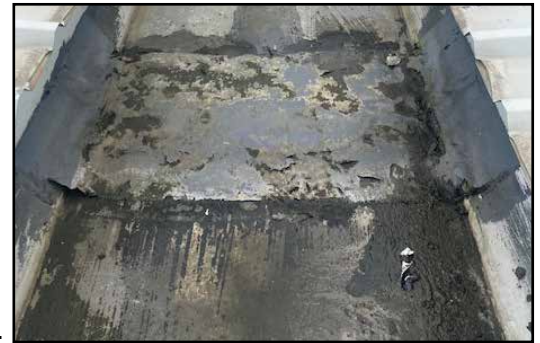
During periods of heavy rain, sheets of water were falling onto production machinery and stock causing major issues. The client requested that the worst affected areas were prioritised and that all the gutters would be treated to repair the leaks.

1. General condition of existing valley gutters
2. Condition of existing valley gutter
3. Completed Works
4. Close up of the completed application

In accordance with System leaflet RPA-06, the gutters were totally cleaned and obvious holes were repaired Belzona 1212. Belzona 3921 (GSC Surface Conditioner) was applied to all surfaces, followed by application of the full Belzona 3111 system.
