HEAT EXCHANGER WAS RECOVERED AND PROTECTED WITH BELZONA

Geothermal Power Plant, Turkey

Repair and coating process for tube sheets, covers and flanges on 2 faces of a 12 meters long Heat Exchangers in a Geothermal Power Plant. The Belzona coating to be applied had to be resistant to chemical washing.

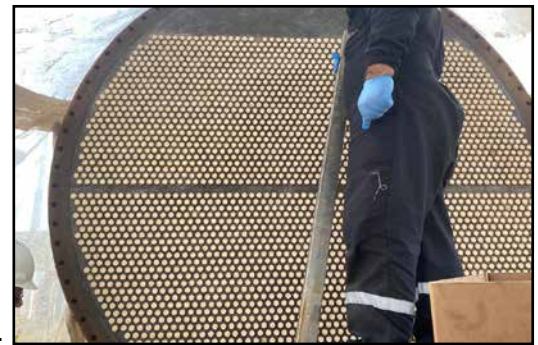
1. Cork stoppers are installed after grit blasting
2. Belzona 1111 repairing
3. Belzona 1391T protection on tube sheet
4. Belzona 1391T protection on cover

First of all, the surfaces were grit blasted. Then all the tubing holes were closed with cork stoppers. After repairing was completed with Belzona 1111, the stoppers were removed. After curing, Belzona 1391T coating was applied in 2 layers.
