WATER PUMP THAT THE CUSTOMER INTENDS TO REPLACE COMES TO LIFE WITH BELZONA

Petrochemical Company, TURKEY

August 2020

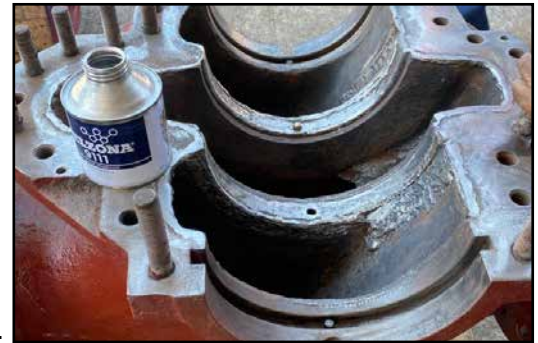
Abrasion caused by corrosion in the pump body as a result of long operating time

1. Belzona 9111 after grit blasting
2. Belzona 1321 coating on Pump Casing
3. Belzona 1321 coating on Pump Casing
4. Belzona 1321 coating on Impeller

The surface was made ready for application by grit blasting in SA 2.5 Standard. The lost surfaces were recovered by filling repairs with Belzona 1311. Then, Belzona 1321 coating was made and the pump body gained high corrosion resistance.
