BELZONA SEALS A WIND TURBINE TOWER BASE

South Wales UK

July 2020

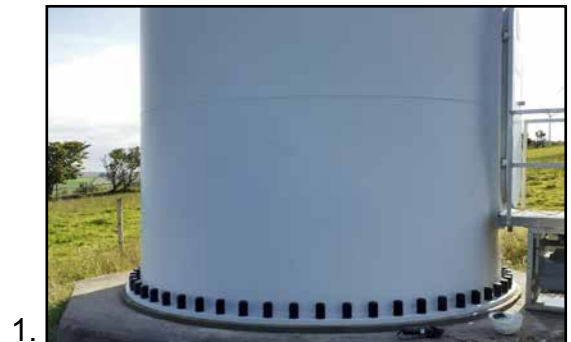
The contractor sought guidance as there were several areas showing signs of metal corrosion and minor cracks to the concrete areas of two bases. A repair and protect solution was required to ensure the asset life could be fully extended a further ten years.

1. Visual preparation
2. Surface preparation, concrete, steel and conditioners
3. Two coat system including reinforcing sheet
4. Fully completed
