BELZONA COATS ENTRY DRIVE ROLLERS WITH A LOW FRICTION COATING

Insulation manufacturer in South Wales.

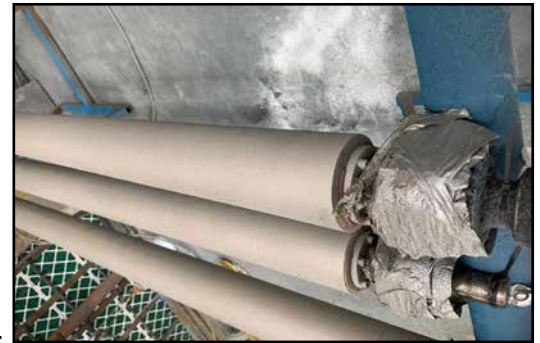
1. Grit blasted substrate
2. First coat Belzona 1341
3. Second coat Belzona 1341
4. Completed bundle of rollers

This is a unique application and has been undertaken by an experienced local coatings contractor for at least five years. Rollers are grit blasted and degreased, with Belzona 1341 applied as a two coat system in accordance with the Instructions for Use. This application is also applied in accordance with a modified version of Belzona System Leaflet SHM-12.
