## CONTINUOUS CASTING LADLE TURRET BEARING REPAIR WITH BELZONA

Steel Plant South Wales

October 2020

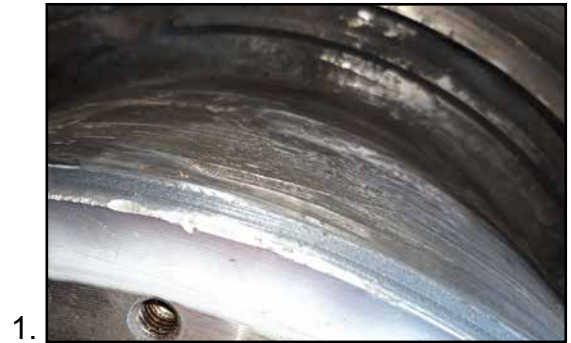
The collapse of one bearing had damaged the bearing seat area putting the machine out of use. The shaft diameter is 450mm and the width of the damage was 200mm with up to 6mm in depth. There were no spares available and due to difficulty in machining the shaft and the tight tolerances needed, Belzona were asked if we could help.

1. Top of the damaged area on the shaft and how access was difficult
2. Overview of the shaft and bearing housing area
3. Former manufactured for this repair
4. Finished repair after removal of the former
