BELZONA SUPERWRAP II USED AT A SEWAGE TREATMENT PLANT

Erosion and perforation at the base off the steel tank.

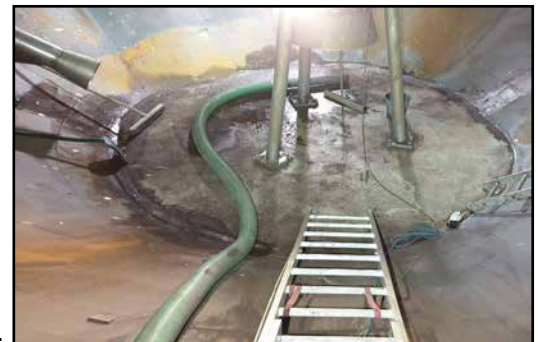
A length of 2 m and a width of 0.5 m, in the lower part of the bottom of the tank, the steel wall thinned from 5 mm to 4.2 mm; 3.8mm; 2.4mm in one place 1.8mm with one leak (a hole with a diameter of 5mm). It occurred as a result of abrasion in this area and sub-cladding corrosion. The bottom of the tank rests on the concrete foundation. The Tank diameter - 20m, mild steel St3S, conical bottom. The original sheet thickness 5mm. Working temperature in the tank 30-40 °C.

1. Internal of the Tank Image
2. Application of SuperWrapp II Image
3. Application showing Belzona 5821 & Belzona 2211
4. Complete Application

To begin with abrasive blasting were completed in accordance with International Standards followed by removal of dust and degreasing. Repair of perforation and strengthening the shell weld with Belzona 1111 composite Belzona 9341 we completed in accordance with Belzona System Leaflet TCC-01. Belzona SuperWrap II system application was used to repair most areas exposed to erosion then followed by application of Belzona 5821 as a top coat. Completed in accordance with an adapted version of VPF-11 and TCC-03. Concrete expansion Joints beneath the steel jacket that came in contact were completed in accordance with Belzona System Leaflet FPA-06 where Belzona 2911 and Belzona 2211 were applied.
