BELZONA TECHNOSOL REPAIRS DAMAGED BUND WALL

Staffordshire, UK

August, 2020

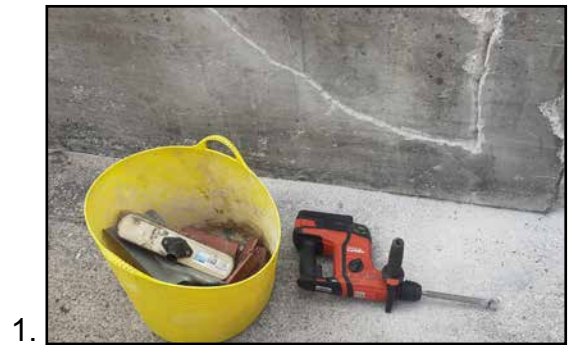
Bund wall and fillet area needed repairing after a collision with a forklift truck caused damage to 2 linear metres of wall to floor joints.

1. Damage to wall
2. Damage to fillet
3. Completed repair to wall
4. Completed repair to fillet

The products were applied in accordance with Belzona System Leaflet TCC-09. The surface was prepared on the external wall of the bund and rebuilt back to its profile using Belzona 4141. After removing approximately 2 linear metres of fillet, Belzona 4181 was used on the internals to restore the damaged concrete..
