BOLSTER SIDE BEARER MOUNTING FACE REPAIR WITH BELZONA 1111

A rail operator have discovered serious corrosion between the side bearer top plates, vehicle body shims and the vehicle bolster structure.

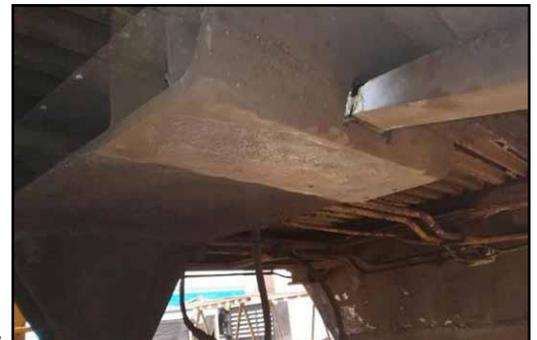
Exfoliation corrosion has occurred between the body shims and the side bearer top plate mounting on the vehicle bolster structure. The options for repair was to carry out a weld repair and subsequent machining operation to re-instate the bolster surface. However, this was not a preferred option due to time and complexity.

1. The damage on the bolster.
2. The application plates that will be attached to surface using belzona 1111
3. Belzona 1111 on the application plate in a pyramid form
4. Finished application.
