## BELZONA 1813 PROTECTS A FAN WHEEL AT A GRAVEL PLANT

**CUSTOMER**  
Switzerland

**APPLICATION DATE**  
November, 2020

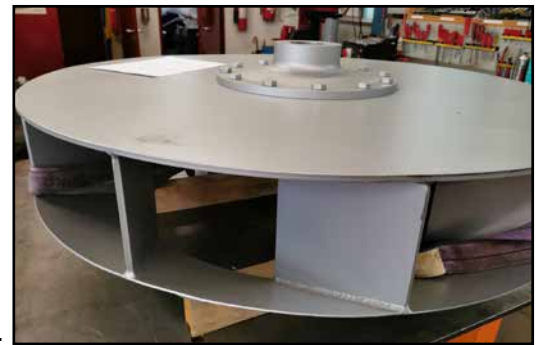
1. Fan Impeller Grit Blasted
2. Belzona 9811 Applied onto Belzona 1391T
3. Belzona 1813 applied to the Belzona 9811
4. Complete Application

**APPLICATION METHOD**  
The fan impeller was grit blasted in accordance with the standard Belzona surface preparation. They then applied Belzona 1391T and attached the Belzona 9811 Alumina tiles to offer extra abrasion resistance and grouted with Belzona 1813 in accordance with a modified version of Belzona system leaflet SHM-7.
