PHARMACEUTICAL PLANT USES BELZONA SAFETY GRIP SYSTEM

CUSTOMER
Switzerland

APPLICATION DATE
May 2020

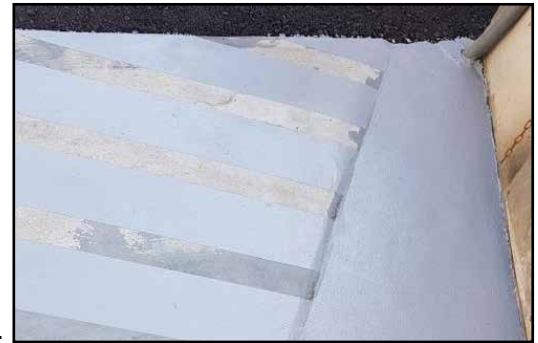
- PICTURES**
1. Application of Belzona 5231
 2. Strips of Belzona 5231
 3. Close up
 4. Final Application Complete

APPLICATION METHOD
Areas of concrete were repaired with Belzona 4111. The Belzona 5231 was applied in accordance with System leaflet FPA-8 to the concrete and then the Belzona 1821 and Belzona 9211 grip system was used to create a safety grip system then overcoated with Belzona 5233 for increased UV Stability.
