BELZONA SUPERWRAP II APPLICATION INSIDE MARINE SEWAGE TANK

Scotland

July 2020

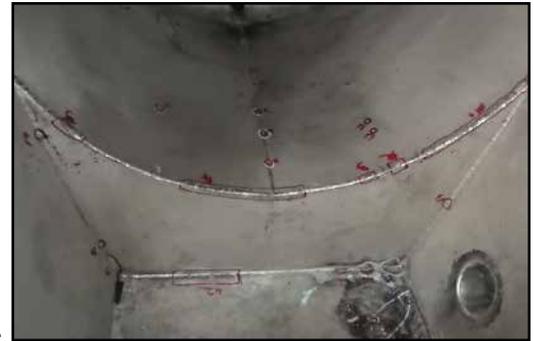
A stainless steel marine sewage tank was experiencing extensive metal loss through pitting corrosion. The welds within the tank were being badly affected & the customer was concerned the tank would soon begin to leak.

1. The areas of metal loss are marked in red here
2. Surface preparation, the tight access is apparent. Aluminium Oxide grit was used to achieve the required surface profile on stainless steel.
3. Belzona Superwrap system applied to walls & tank base. The ability to encapsulation complex geometry is shown here
4. Belzona 5811 applied
