BELZONA TANK BASE SEALING IN SERVICE FOR OVER 15 YEARS

Refinery, Croatia

Water penetration to tanks base at a refinery in Croatia.

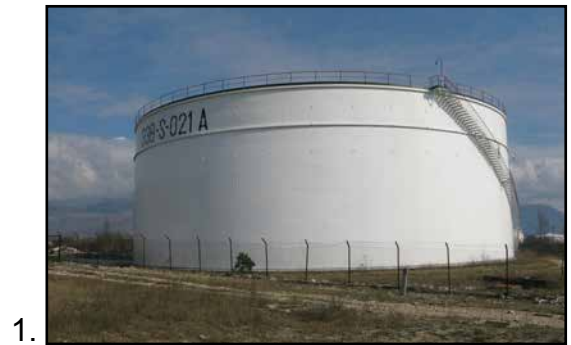
The conventional bituminous method with UV coating failed. Water was penetrating into the tank base. The customer demanded a permanent solution and demanded a 5 year guarantee.

1. Tank before application.
2. Application in progress.
3. Protected surface 15 years after application.
4. Tank after 15 years after application.

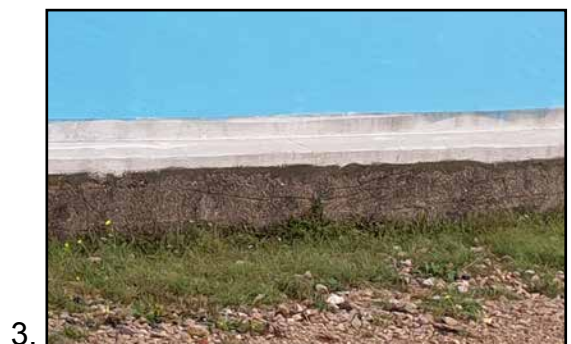
Annual visual inspections were carried out and the system proved to be flawless and permanent. The protection systems ability to let water out but not to let water in provides longevity in service.
