BELZONA DISTRIBUTOR'S OVEN HELPS FOR QUICK RETURN TO SERVICE

Customer needed to protect their heat exchanger parts in cold weather conditions to then be placed back into service within 24 hours.

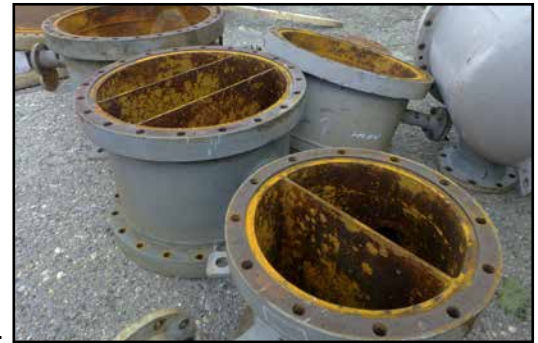
Erosion and Corrosion to the exchanger parts required repairing. Belzona 1391T's time until full service was 28 days in 20°C so post curing was required.

1. Customer needed to protect his parts of exchangers
2. Blasting and cleaning
3. Garage oven with remote temperature control
4. Coating exchanger parts to post cure
