## BELZONA CHOCKING COMPOUND STABILIZES A LATHE

Installed lathe at a machine building manufacturer which required a solid foundation.

Lathe required a solution to withstand compressive load of machinery and reduce vibrations.

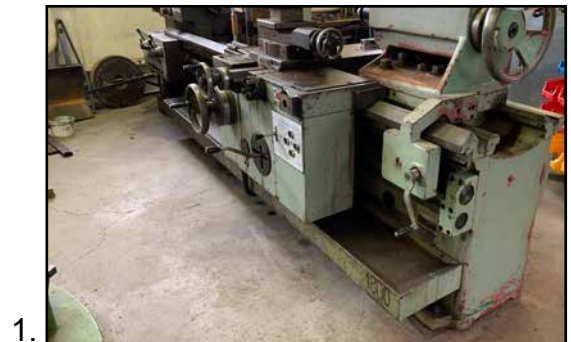
1. Installed lathe required a solid foundation
2. Temporary wood dam prepared
3. Pouring Belzona 7111
4. Final Application
