PENSTOCK OUTER SURFACE COATED WITH BELZONA

Hydro Power Plant, TURKEY

September 2020

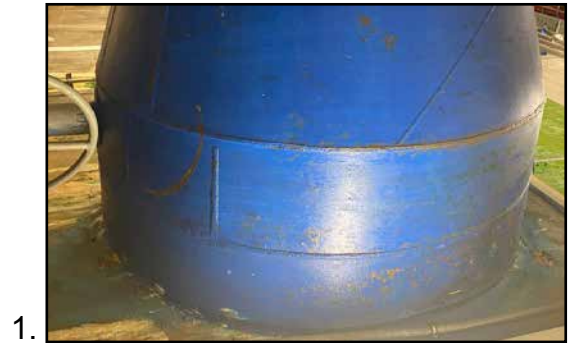
The outer surface of the penstock was constantly exposed to moisture. Previously painting swelled in a short time.

1. Before surface preparation, painted surface
2. After grit blasting
3. When applying the second coat of Belzona 5831
4. End of application
