BELZONA SOLUTIONS FOR HEAT EXCHANGERS

Burbank, CA

December 2020

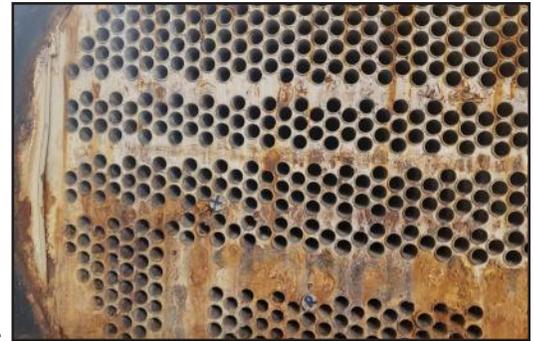
If the corrosion allowance is exceeded and gaps appear, recirculation can occur, leading to efficiency loss. In addition, the processed fluid can erode the metal further, accelerating degradation if corrosion is already present.

1. Corroded tube Sheet
2. Blasted Tube Sheet
3. Repaired and Coated
4. Final Results of Repair

The affected section is rebuilt using Belzona's two-component repair composites. The paste grade material Belzona 1311 rebuilds the substrate to its original tolerances, while the fluid grade system Belzona 1321 (Ceramic S-Metal) provides a layer of durable protection. This cold-applied repair process bypasses the need of hot work that would leave the substrate susceptible to further damage. Belzona polymeric technology isolates the dissimilar metals, preventing further galvanic corrosion. The tough repair and coating system also protects the chiller against the effects of erosion and, as a result, increases asset life and efficiency while avoiding replacement. Belzona materials are easy and quick to apply by hand, reducing downtime and hazards during application.

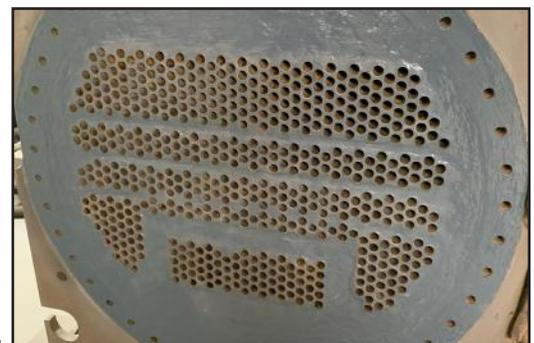
4.

The Belzona solution not only restores the original tube sheet profile, but also creates a smooth tube sheet face flush with the tube ends, leading to reduced turbulence and greater efficiency. Water boxes and end covers can also be repaired and protected.
