## BELZONA REPAIR THE WELDING ALUMINUM SEAMS

Slovakia, heating plant

2014

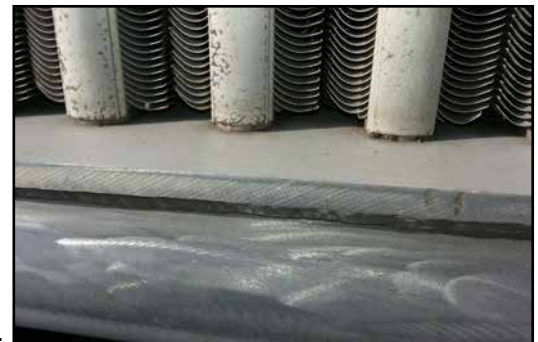
Vacuum condenser has aluminium construction. Source of the cracks on the welding seams is mechanical movement from temperature differences.

Cracks in the aluminium

1. Damaged vacuum condenser
2. Blasting
3. Belzona 2211 application
4. After Belzona 2131 application
