SPLIT PUMP KEEPS IT COOL WITH BELZONA

Huelva - Spain

2017

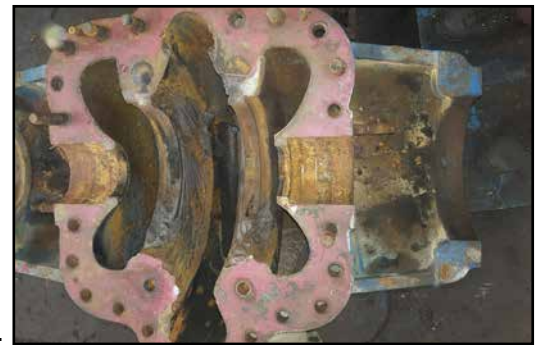
10 years after Belzona 1321 was applied to the split case pump, the coating is now almost completely gone and erosion has removed some of the steel. The customer was happy with the performance of Belzona and wished to utilize Belzona materials to further extend the life of this pump.

Heavy erosion caused by suspended particles in the fluid.

1. Pump after 10 years in service (some Belzona 1321 still visible)
2. Wear ring seating areas rebuild with Belzona 1311
3. Most severely worn areas rebuild and protected with Belzona 1812
4. Remaining areas rebuild with Belzona 1311 & coated with Belzona 1321
