## REPAIR OF SEA WATER FLANGE WITH BELZONA ELASTOMER

SHIPYARD, TURKEY

Sea water flange on Ro-Ro ship.

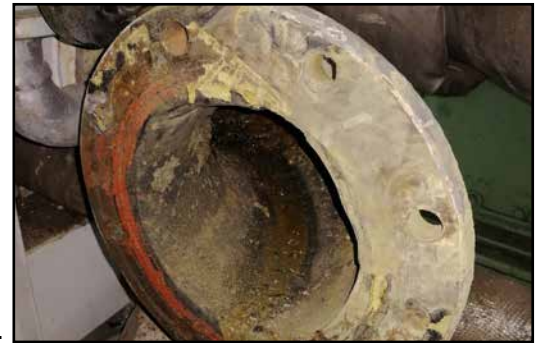
Seawater system flange surfaces were damaged due to corrosion and erosion.

1. Damaged filter flange
2. Abraded flange surface
3. Application of Belzona 2211 on filter flange
4. Application of Belzona 2211 on flange of filter connection pipe
