BELZONA PROVIDES QUICK AND EASY REPAIR OF VERTICAL PUMP SHAFT

A large scale power plant in Anhui, China

The water pump is manufactured in a Chinese domestic pump factory. The shaft is a vertical circulating water pump spindle with a shaft power of 2034 KW and a flow rate of 37620 m³/h.

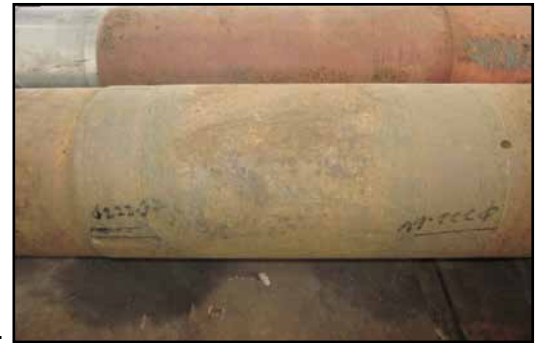
Most parts of the vertical water pump shaft sleeve appear over 1 mm abrasion, causing serious vibration during operation, which leads to increase in energy consumption of the electric engine and safety risks. Due to the large abrasion area and its thickness, brush plating and bead welding repair are unavailable.

1. Shaft diameter decrease and becomes irregular
2. Achieve thick thread after cutting
3. Spline rebuild and repair completed
4. Processing complete matching the shaft sleeve perfectly
