90 YEAR OLD CAST IRON LAKE DISCHARGE SYSTEM

Ft. Worth Texas

November 2019

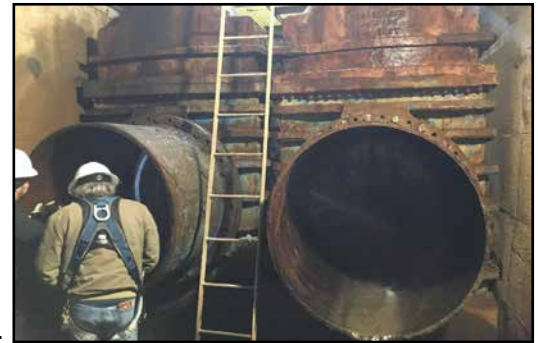
1. Bonnets, valve bodies and pipe prior to Blasting
2. Bonnets prior to blasting
3. Bonnets coated
4. Valve bodies and pipe coated.

Application was carried out by abrasive blasting the cast iron to SSPC SP10, whilst keeping a heater running in the area to keep the temperatures in the mid 60's °F (>15 °C), raising the temp of the material to between 68-70 °F (20 °C to 21 °C) for the Belzona 5811. The first coat was applied, a second coat was applied within 24hrs to ensure proper coverage on the valve bodies. On the bonnets and pipe, Belzona 5831LT was applied whilst controlling the running water in the pipe with a makeshift dam. On the bonnets that were sweating, the surface was grit blasted and dried before applying Belzona 5831LT immediately.
