BELZONA PROVIDES CORROSION PROTECTION FOR HYDROCHLORIC ACID CHEMICAL TANK LINING

Petroleum Company in Guangdong, China

July 2014

hydrochloric acid chemical tank

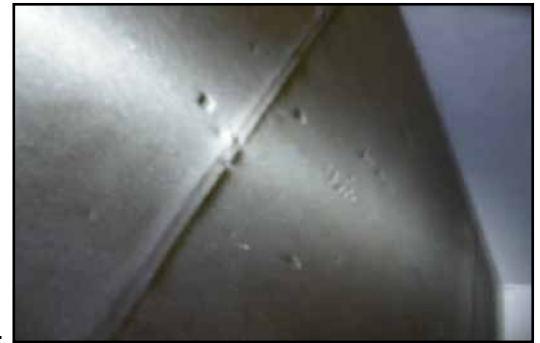
The chemical tank lining has experienced chemical corrosion, which could lead to safety hazards.

1. Corrosion situation of metal surface
2. Measure roughness of blasted metal surface
3. Measure thickness
4. Tank lining repaired
