WATERPROOFING COVERED LABORATORY BUILDING WITH BELZONA SYSTEM 3111

Coal Thermal Center in AS Pontes-Galicia

Flat cover of the main laboratory building within the thermal centre of As Pontes-Galicia

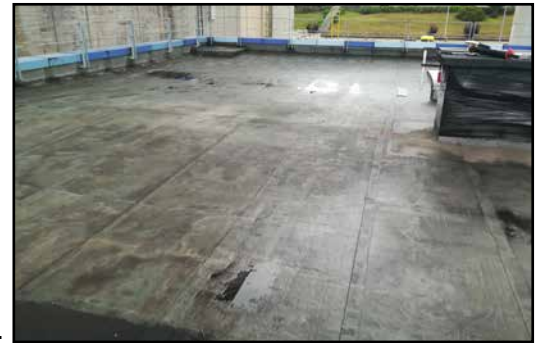
The deterioration of the asphalt lining in some areas were applied on the concrete roof of the laboratory roof, facilitated the entry of water into the offices and test offices, spoiling highly expensive measuring and testing equipment.

1. Start status
2. Cleaning
3. Application of Belzona 3111
4. Final state with second coat of Belzona 3111
