PAPER & PULP PLANT TANK REPAIRED WITH BELZONA 5892

Condensate tank suffering from corrosion.

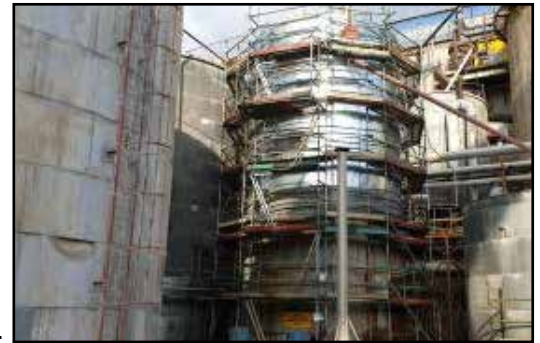
Internal of the condensate tank at the paper & pulp plant was suffering from corrosion.

1. Condensation Tank
2. Application of Belzona 5892
3. Belzona 5892 2nd layer
4. Application Complete

Substrate grit blasted to surface cleanliness (Sa 2 1/2). Followed a profile check for the min surface roughness of 75 microns. Degreasing surfaces with Belzona degreaser 9121 and applied Belzona 5892 in a two coat system. The application was completed in accordance with Belzona System Know-How Leaflet TCC-05.
