## DAIRY FARM WASH STATION PROTECTED WITH BELZONA 4181

The floor in a wash station of a dairy plant had a number of issues due to the unsealing of joints.

Unsealing of the joints in the dairy plant wash station causes floor destruction.

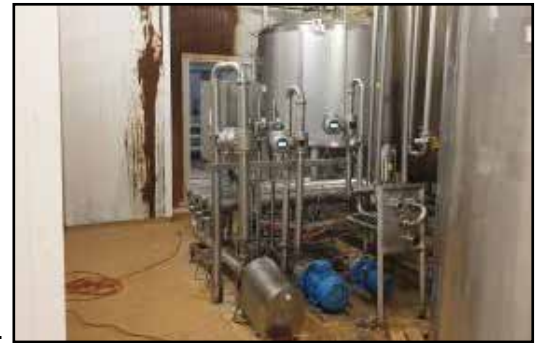
1. Damaged chemically resistant floors
2. Belzona 4111 around the drain.
3. Application of Belzona 4181
4. Complete Application

The Application was completed in accordance with Belzona Know-How System Leaflet FPA-01. Removal of damaged concrete and leveling the pump work area. Belzona 4111 applied around the damaged drain area. Belzona 4181 used to provide a chemical resistance to the floor area then post cured by heating the Belzona 4181 for 4 hours.
