BELZONA PROVIDES CORROSION PROTECTION FOR HEAT EXCHANGER TUBE SHEETS

A chemical plant in Nanjing, China

Heat exchanger tube sheet in a chemical plant.

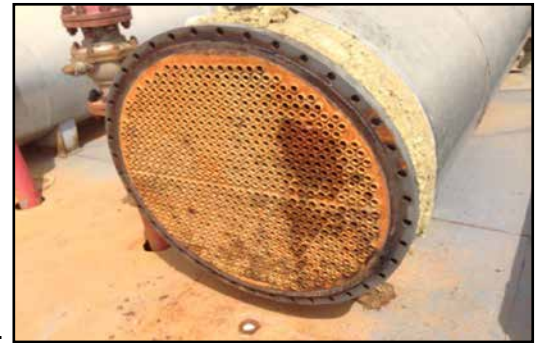
1. Heat exchanger tube sheet before grit blasting
2. Grit blasted heat exchanger tube sheet
3. Repaired pitted areas using Belzona 1111
