SLIDE ASSEMBLY WITH BELZONA REPAIR

Slovakia, metallurgic producer

2014

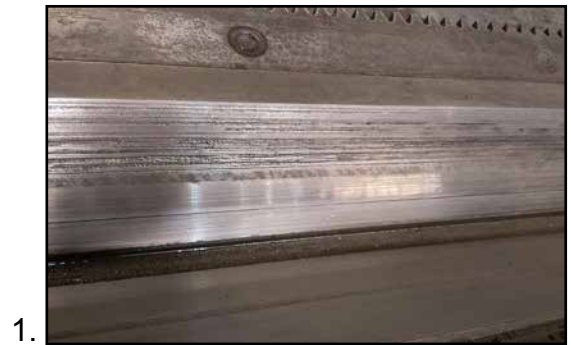
Slide assembly were damaged from corrosion.

Corrosion accelerated due to the inclusion of water and chemicals within the process

1. Damaged slide assembly
2. Belzona 1311 application
3. All surface were sanded down
4. Support ready to work
