## BELZONA REBUILDS SEAWATER FILTER FLANGES

Shipyards, ISTANBUL, TURKEY

Seawater filters of a container ship.

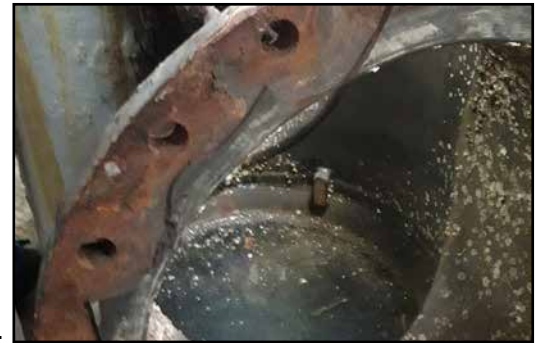
Pitted surface and metal loss due to erosion and corrosion on the seawater filter flange.

1. Erosion and corrosion damage on the flange.
2. After surface preparation.
3. Application of Belzona 1111 with applicator.
4. After Belzona application.
