BELZONA 4111 REPAIRS A FLOOR IN A MANUFACTURING FACILITY.

Floor damage due to heavy traffic in a manufacturing facility.

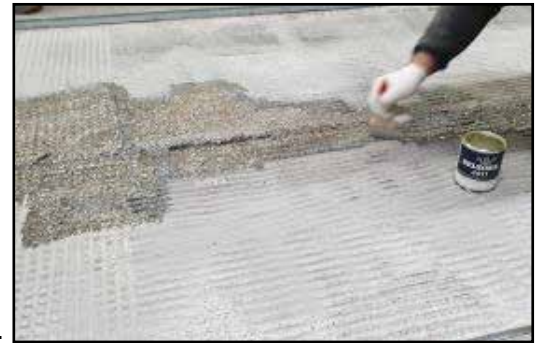
1. Ensure cavity's are clean and prepared
2. Fill cracks and cavities with Belzona 4111
3. Belzona 4111 composite application in liquid form
4. Completed Application

The surface was prepared by cutting out the floor cracks and vacuuming the surface. Belzona 4151 was used to impregnate the floor then Belzona 4111 was applied.
