ACID MIXING TANK DRIP MITIGATED WITH BELZONA

APPLICATION SITUATION
Repair and protection of a concrete containment area in a brewery.

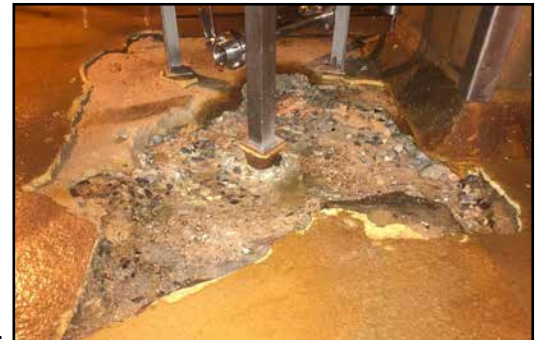
PROBLEM
Regular dripping from the acid mixing tank was causing severe degradation to the concrete at the feet of the tank. The acid mixture had been absorbed into the concrete, threatening to damage the supporting structure.

1. Original condition of damaged concrete
2. Post cleaning, surface primer being applied
3. Concrete rebuilding
4. Complete application
