## BELZONA PROTECTS BRAND NEW FERTILIZER PLANT

Brand new granulating plant in a fertilizer factory containing 98% sulfuric acid.

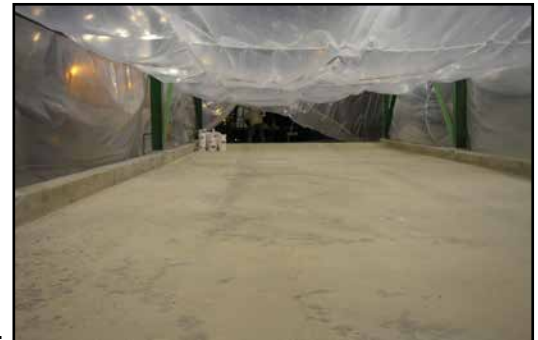
1. Application area being tented out
2. Belzona 4311 after being applied
3. Coated fertiliser plant area
4. Wear pads and flooring system 8 years later

Application was carried out in accordance with Belzona Know-How system Leaflets TCC-15 and TCC-08. The outside area was tented out and the new concrete was coated with Belzona 4311. A special mortar mix of Belzona 4151 and AL203 ceramic aggregate was made for the 2 pads for the tractors feet to rest on, yellow tinted Belzona 4151 safety lines were also applied to help the driver park the tractor easily.

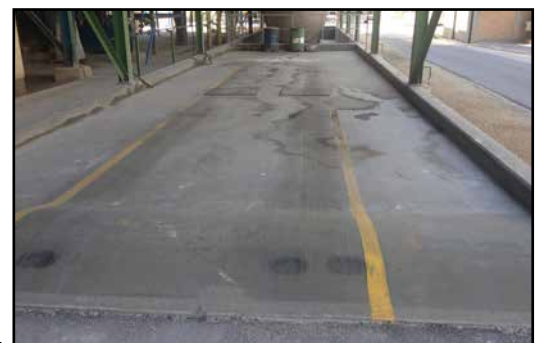
4.

Over the years it was found that when the tractor picked up the tanker it would push it 10-20 cm backwards, damaging the Belzona 4311 coating with it's metal feet. To prevent this 2 wear pads were mixed and applied. 8 years later and the system is still in good condition.
