BELZONA PROVIDES PROTECTION FOR STATE-OWNED REFINERY TOWER

State-owned oil refinery plant in Hunan, China

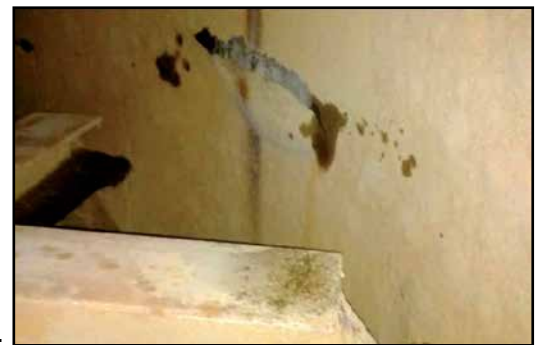
2.

This complex tower in an oil refinery plant has been corroded by acid and alkali substances (such as H_2S , SO_2 , H_2SO_3 , H_2SO_4 , $NaOH$) for a long time, resulting in the failure and cracking of the original coating. The stainless steel bracket inside the tower also appears various degrees of corrosion.

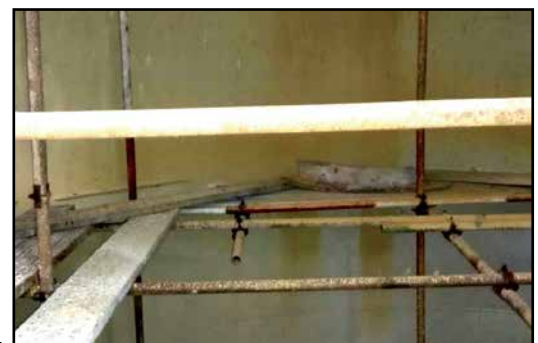
4.

After Belzona coating has been in service for one year within an environment which contains acid and alkali substances (H_2S , SO_2 , H_2SO_3 , $NaOH$), according to on-site inspection, the overall surface of the inner coating looks very smooth, showing no leaking, shedding, bulging, cracking or other failure symptoms. Vessels protected with Belzona coating are easy to clean and able to continuously meet the requirements of anti-corrosion design and anti-corrosion protection requirements for the safe operation of the refinery.
