BELZONA REPAIRS A THRUSTER

Stern Thruster for sea going vessel has a large degree of pitting due to erosion-corrosion by sea water.

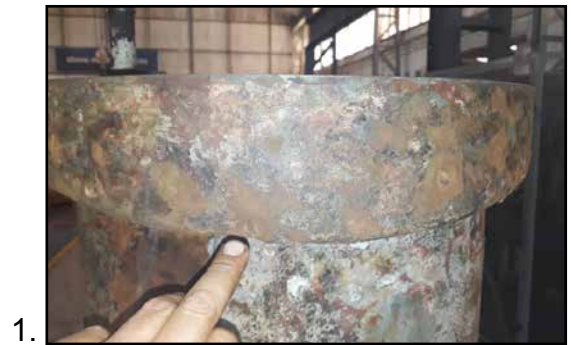
Heavily pitted and corroded on the out side of the thruster housing which would be costly and time-consuming to repair.

1. Pitted Housing
2. After grid blast
3. After applying Belzona 1111
4. Final coat Belzona 1321
