BELZONA REPAIR ON A THRUSTER BODY

Thruster body repair.

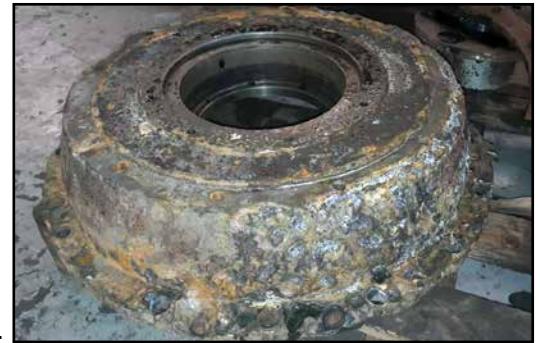
Heavy wear on body of thruster due to sea water.

1. Before
2. After repair with Belzona 1111 and Belzona 1321.
