BELZONA SUPERWRAP II ON-SITE APPLICATION FOR CUI

Lubricating oil pipeline; Diameter is 250mm; Normal operating pressure is 2MPa while instantaneous pressure could be up to 5MPa.

Corrosion under insulation(CUI).

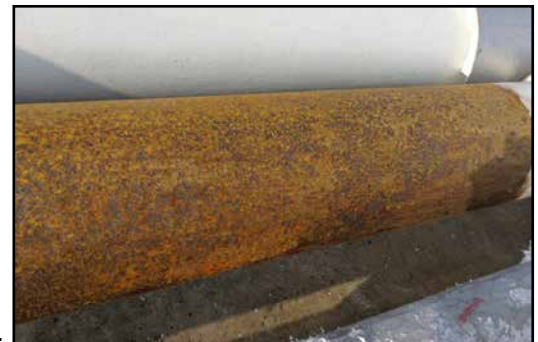
1. Damaged pipelines before application
2. Repair pitting spots with Belzona 1111
3. Multiple layers applied in accordance with designing requirement
4. Application complete before release film removal
