OIL AND GAS WEMCO TANK AGITATOR - 3 YEARS ELASTOMER WEAR PAD

Gulf of Mexico

March 2017

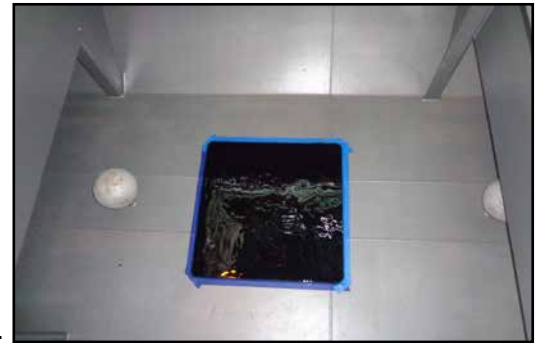
1. Belzona 2131 wear pad applied in March 2017
2. Belzona 2131 wear pad after 3 years of service in March 2020
3. Small surface defects will be touched up with additional 2131 to ensure another 3+ years of service.

Belzona 2131 D&A Fluid Elastomer was applied by brush and applicator in a square patch to cover over the substrate where erosion was noted.
