TANK BASE SEALING

Oiltanking Odfjell Terminals & Company, Sohar, Oman

Water ingress on the underside of a tank.

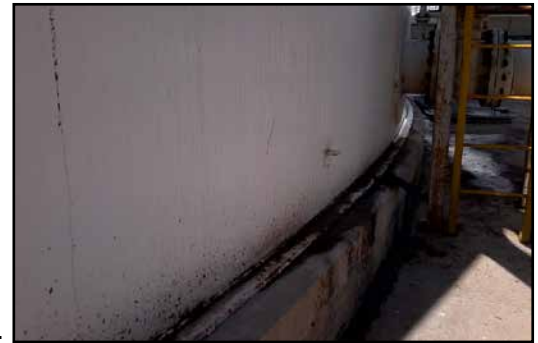
Due to the moisture ingress in the tank bottom side of the bottom plate annular ring area suffers corrosion and leads to material deterioration, thickness reduction and results to leakage. The client is looking for the long term solution to protect their 57 tanks.

1. Annular Plate condition before application
2. Completion of Tank Base Sealing
3. Close look of Tank Base Sealing
