BELZONA REPAIRS LEAKING FIRE WATER PIPE LINES OF A NAVY SHIP

CUSTOMER
NAVY

APPLICATION DATE
2019

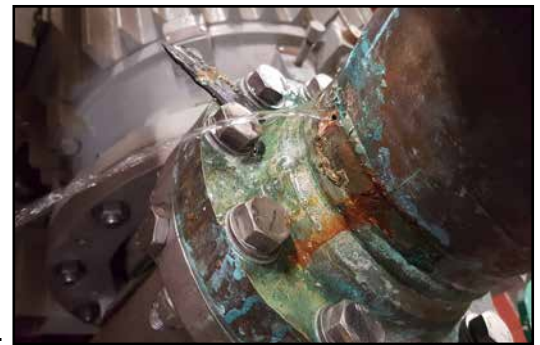
APPLICATION SITUATION
The fire water pump piping was leaking with no replacement pipe available

PROBLEM
The pipe was leaking causing local flooding in the engine room. The navy tried to seal the leaking pipe with other products, but this had failed & was still leaking. So they contact Belzona

- PICTURES**
1. Leaking pipe
 2. After surface preparation
 3. Repair in progress
 4. Completed application
